CITY OF BALTIMORE WET SMOKE AND DYED I	Page 1 of 9				
Sewershed: Low Level Subsewershed: 44	Company: REI/DRAYCO	Date: 08/25/2008			
Test Type: Smoke	Ground Condition: Dry: X Damp:_ Wet:_	Supervisor: E.R. Crew: 03			
Manhole ID: S17K001MH	Test ID: 1029-548	Notifications Made:X_ Residents, Fire, 311			
Field Sketch: (Show all manholes with numbers, blower placement location, sandbag or isolation locations, street names, building addresses

CITY OF BALTIMORE SMOKE TESTING OBSERVATION SUMMARY LOW LEVEL SEWERSHED

BALTIMORE CITY PROJECT 1029 REI/DRAYCO

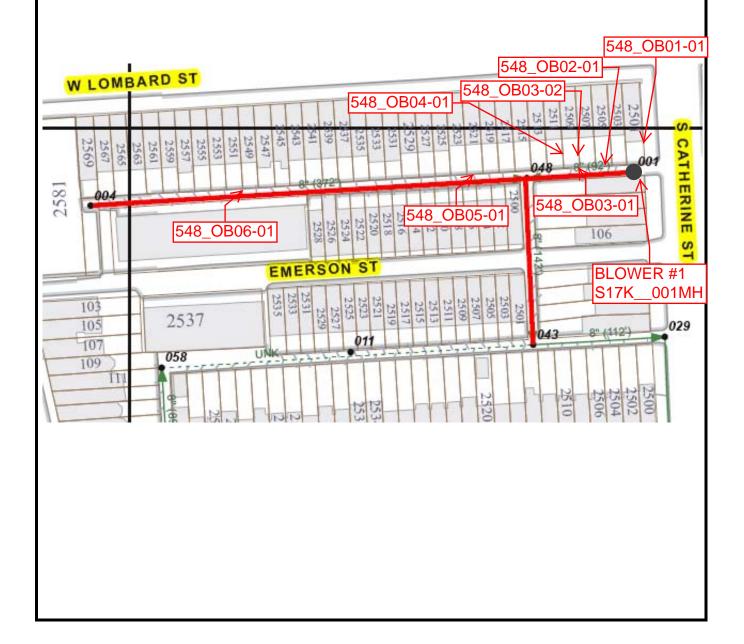
Field Sketch: (Show all manholes with numbers, blower placement location, sandbag or isolation locations, street names, building addresses and locations, defect locations and photograph numbers)

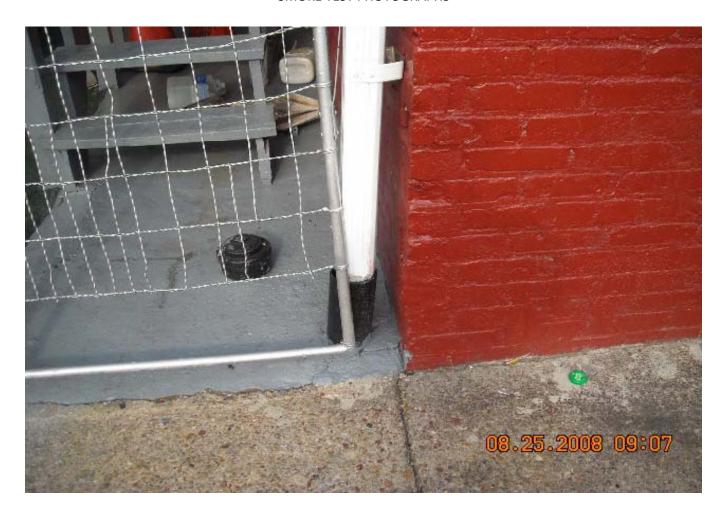
Photograph No: OB01-01 Filename: 1029-548_OB01-01.jpg

Location: 2501 W. LOMBARD ST.

Source Type: 04 Downspout Sector: 02 Private

Location: 09 Yard - Side Severity: 03 Moderate Drainage Area: 400

Comments: SMOKE COMING FROM DOWNSPOUT.

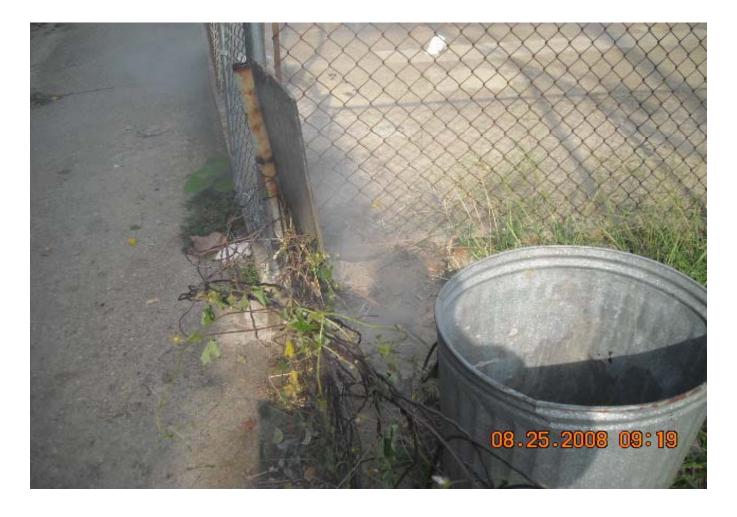
Photograph No: OB02-01 Filename: 1029-548_OB02-01.jpg

Location: 2505 W. LOMBARD ST.

Source Type: 02 Service Line Sector: 02 Private

Location: 08 Yard - Back Severity: 03 Moderate Drainage Area: 6

Comments: SMOKE COMING FROM HOLE LOCATED BELOW PLYWOOD BOARDS.

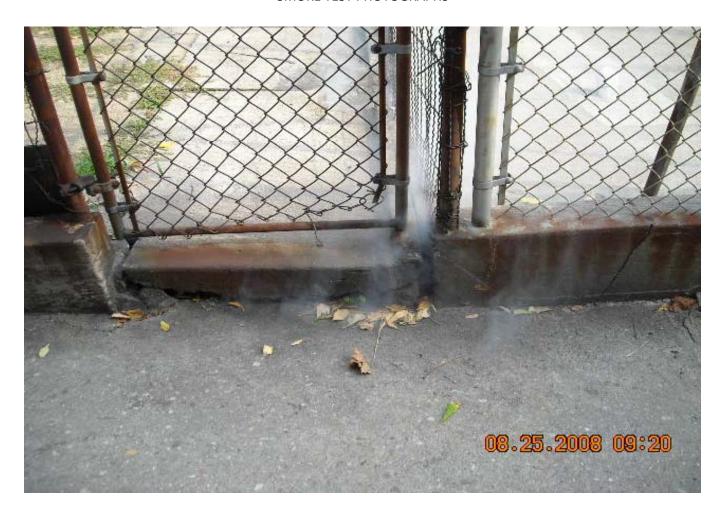
Photograph No: OB03-01 Filename: 1029-548_OB03-01.jpg

Location: 2509 W. LOMBARD ST.

Source Type: 02 Service Line Sector: 02 Private

Location: 06 Curb Severity: 03 Moderate Drainage Area: 25

Comments: SMOKE COMING FROM BENEATH CONCRETE SLAB AND ALONG FENCE GOING TOWARDS

HOUSE.

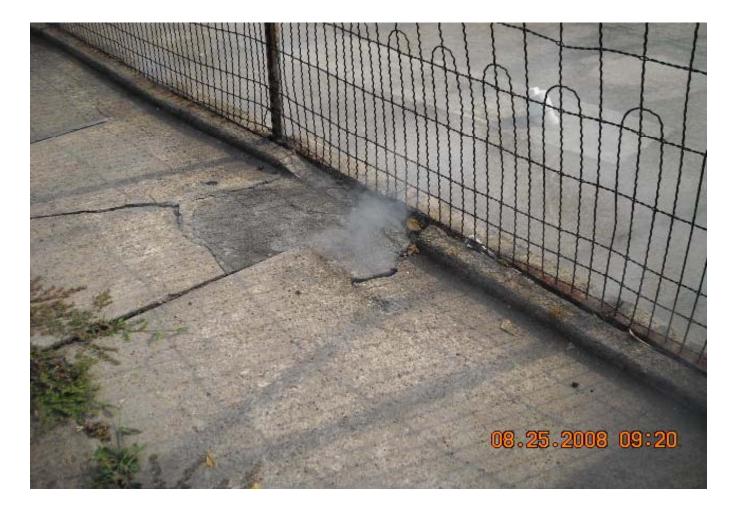
Photograph No: OB03-02 Filename: 1029-548_OB03-02.jpg

Location: 2509 W. LOMBARD ST.

Source Type: 02 Service Line Sector: 02 Private

Location: 05 Sidewalk Severity: 03 Moderate Drainage Area: 25

Comments: SMOKE COMING FROM HOLE IN SIDEWALK WHICH IS ADJACENT TO 548-OB03-01.

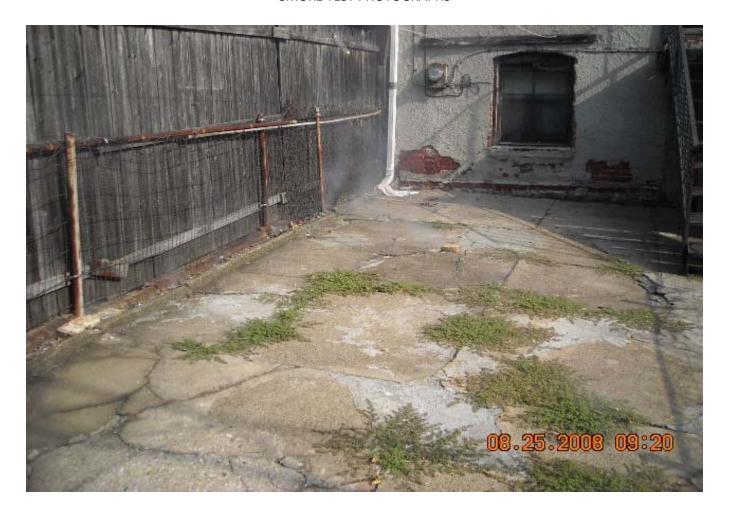
Photograph No: OB04-01 Filename: 1029-548_OB04-01.jpg

Location: 2509 W. LOMBARD ST.

Source Type: 02 Service Line Sector: 02 Private

Location: 09 Yard - Side Severity: 03 Moderate Drainage Area: 50

Comments: SMOKE COMING FROM ALONG FENCE OPPOSITE OF OB03-02 AT SAME ADDRESS.

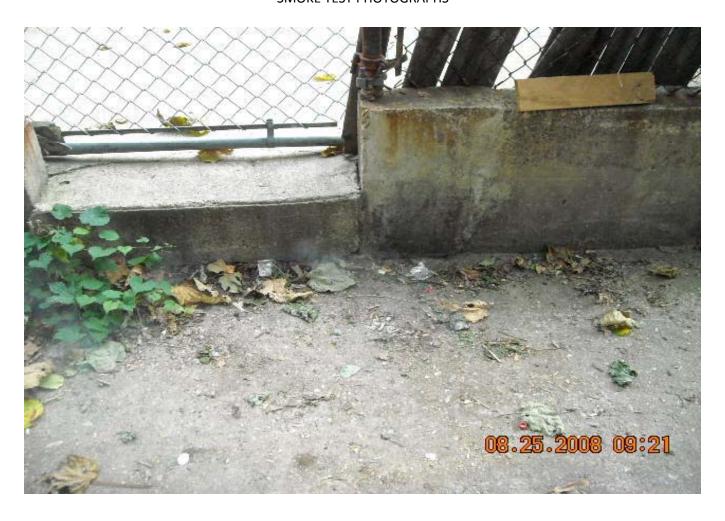
Photograph No: OB05-01 Filename: 1029-548_OB05-01.jpg

Unique Test ID: 548	Date: 08/25/200	08 Basin: LL - 44	Manhole ID: S17K001MH		
Defect No: OB05 Superv	visor: E.R. Crew: 03		Dye Test Recommended: N		
Location: 2521 W. LOMBAR	RD ST.				
Source Type: 02 Ser	vice Line Sect	or: 02 Private			
Location: 06 Cur	b Sever	ity: 03 Moderate	Drainage Area: 10		
Comments: SMOKE COMING BENEATH CONCRETE SLAB AT GATE.

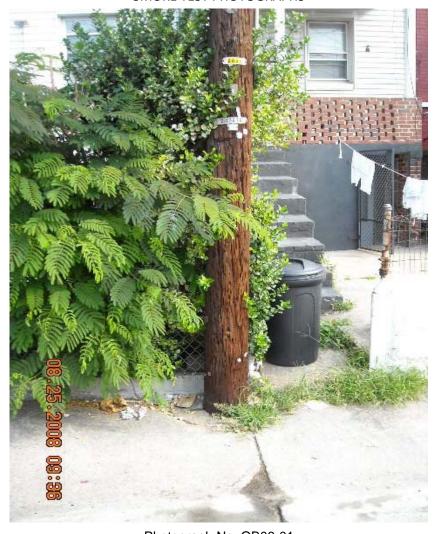
Photograph No: OB06-01 Filename: 1029-548_OB06-01.jpg

Location: 2549 W. LOMBARD ST.

Source Type: 17 Telelephone Pole Sector: 01 Public

Location: 12 Alley Severity: 02 Trace Drainage Area: 4

Comments: SMOKE COMING FROM AROUND BASE OF TELEPHONE POLE.
